Navajo Abandoned Uranium Mine Site Screen Report

NE Churchrock Quivira Mines (No. 1)

Navajo AUM Eastern Region

May 2009

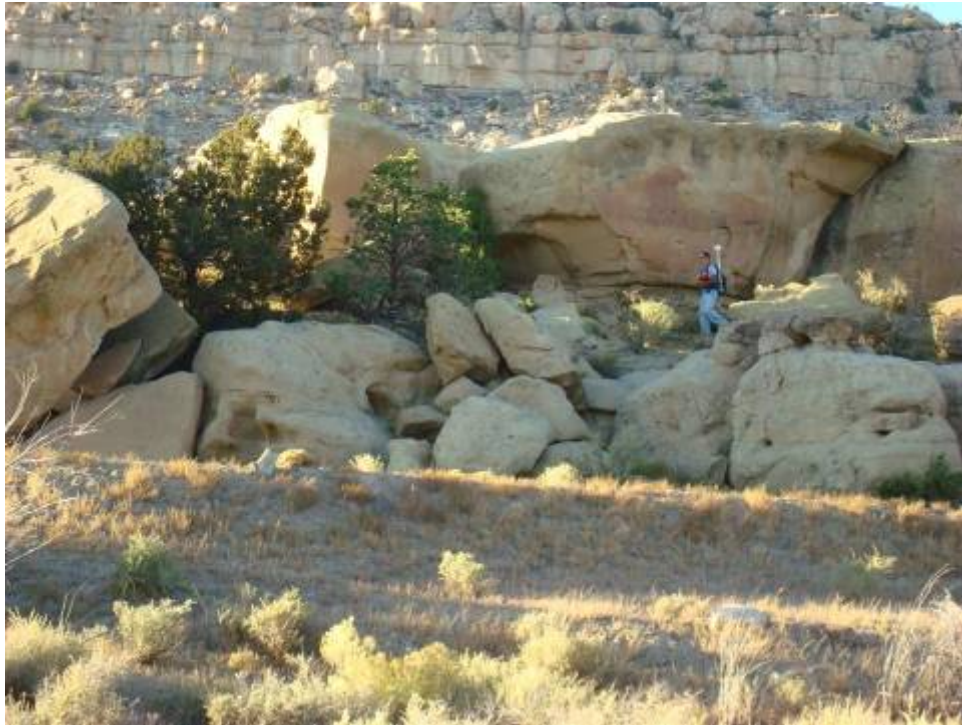
Photo 3: Survey of western mine boundary, towards the north

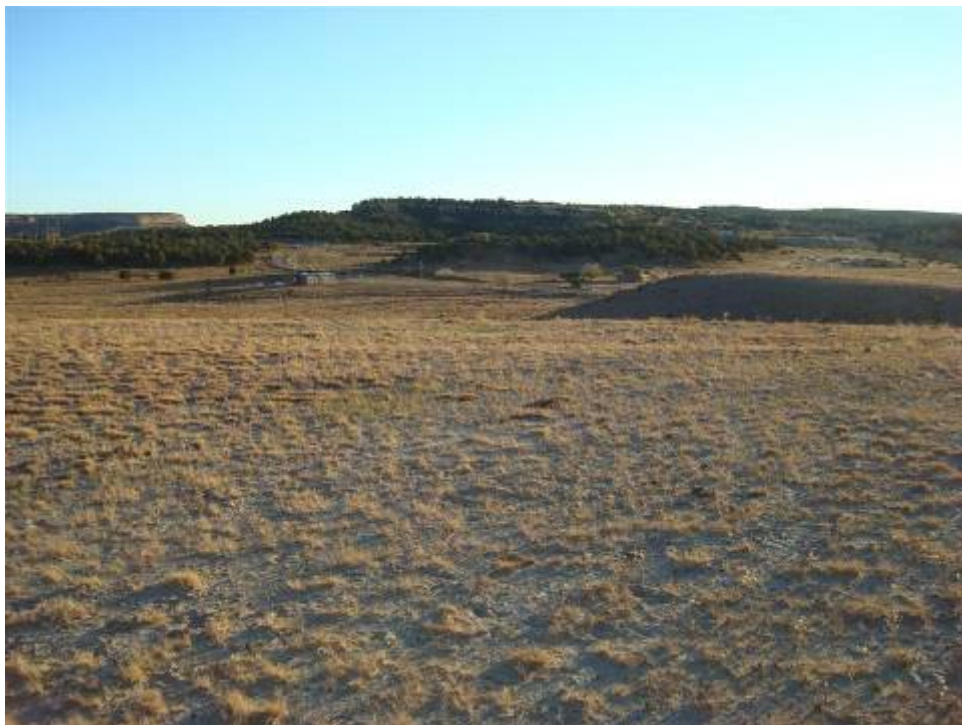
200 feet to 0.25 mile: Five residential compounds located within ¼ mile with the nearest being 680 feet south of the mine.

Photo 4: Southern portion of mine and residence located to the south

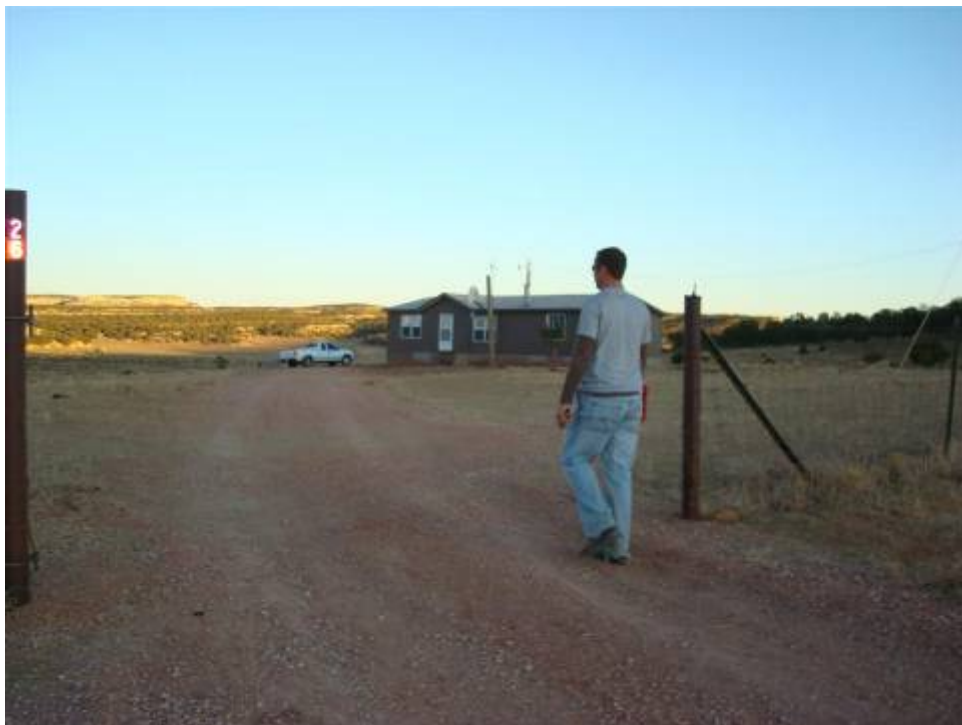
At what distance from the cap/seal is the nearest domestic structure located? 680 feet

Photo 6: Nearest residence located south of the mine.

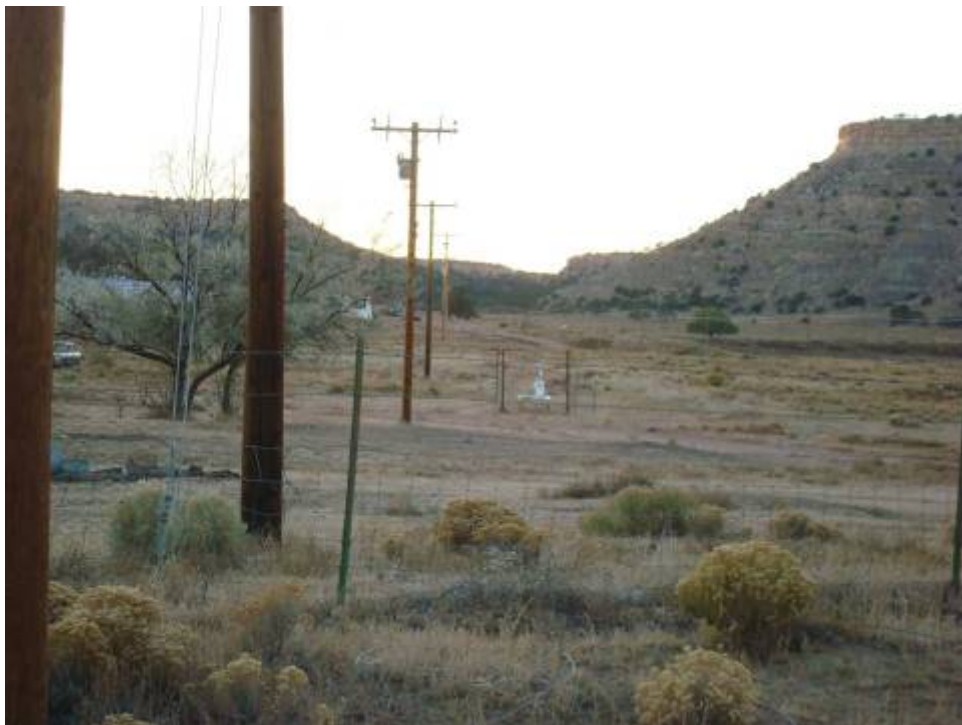
0 to 0.25 miles: Well located 630 feet south of the mine

At what distance from the cap/seal is the nearest domestic drinking water source? 630 feet

Photo 8: Well located between residences and mine.
